# South East Strategic Reservoir Option Preliminary Environmental Information Report

# Appendix 10.3 - Desk study for unexploded ordnance and military uses

# **Desk Study for UXO & Military Uses**

Document Ref. P15306-25-R1

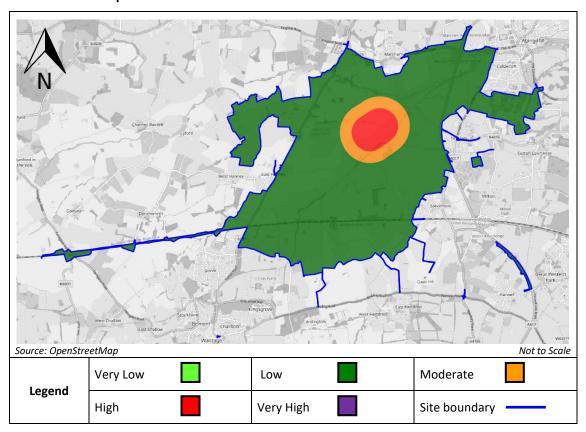
#### UXO hazard zone plan of the Site

During World War Two (WWII), Marcham bombing range was located on the central part of the Site. Although designated for practice bombing, it is known that live bombs were often used on such ranges during wartime.

The typical inner danger area for bombing ranges was 550 yards (yd), centred around the target marker. This part of the Site has been assigned a high UXO hazard level due to the likely presence of practice bombs at shallow depths and potentially live UXBs.

An outer danger area of up to 950yds was common. As such, a 400yd radius around main danger area has been assigned a moderate UXO hazard level to account for potential overspill.

The German bombing density on the Site was low and no other significant sources of UXO hazard or military uses have been identified. The remainder of the Site is assigned a low UXO hazard level.

It is considered that the UXO hazard level on the Site can be zoned from low to high, as shown in the figure below, reproduced as Figure 6 to Figure 8 in the main report.

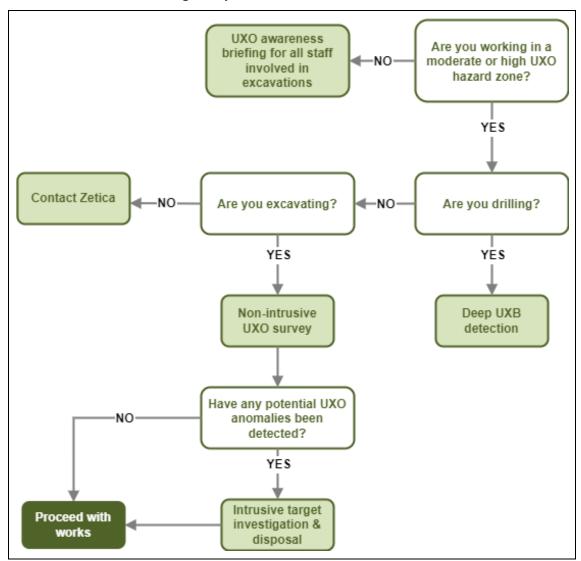
#### Recommended UXO risk mitigation plan for the Site

In summary, in the moderate and high UXO hazard zones, a non-intrusive UXO survey is recommended in advance of excavations and drilling to map shallow-buried UXO. Deep UXB detection is recommend to clear borehole locations of deep-buried UXO.

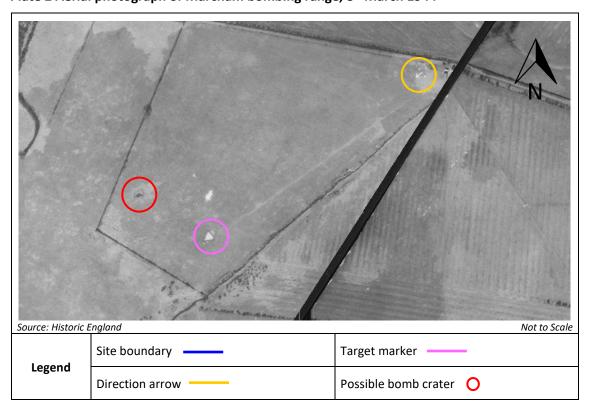
Plate 2 Aerial photograph of Marcham bombing range, 8th March 1944

Cratering may be indicative of live bombs being used on the bombing range. It may also indicate possible jettisoning of live bombs from German or British aircraft. It is known that during WWII aircraft from nearby airfields would sometimes jettison their bombs on bombing ranges.

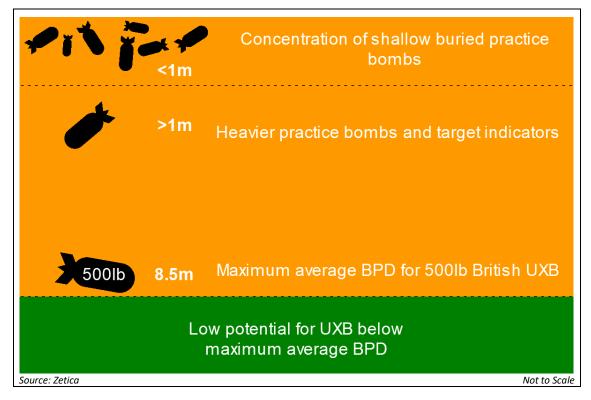
Figure 2 Potential burial setting of ordnance on Marcham bombing range

It should be noted that wartime ranges were commonly used for live practice and may have also been used by aircraft jettisoning their bombs. The potential for live UXB to be present cannot be discounted. These are likely to be buried at greater depths than practice bombs (up to approximately 8.5m below WWII ground level for a 500lb British bomb).

Figure 2 demonstrates the potential burial setting of ordnance on Marcham bombing range, based on the anticipated ground conditions (see Section 4.2.2) and average maximum penetration depths.

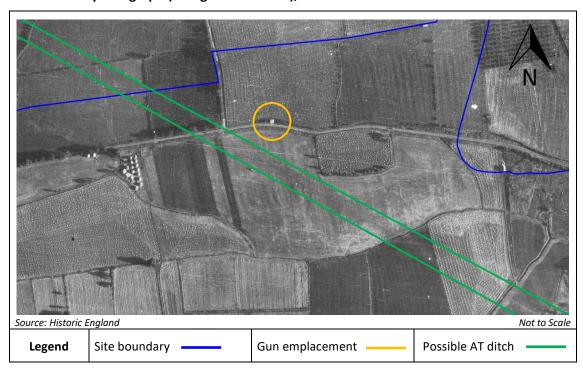
Plate 7 Aerial photograph (Abingdon Common), 9th June 1946

Plate 7 is an aerial photograph of the Abingdon Common part of the Site, dated the 9<sup>th</sup> June 1946. 1No. linear feature has been identified, encroaching on the north-eastern part of the Site, indicative of the filled-in AT ditch. The AT gun emplacement has also been identified.

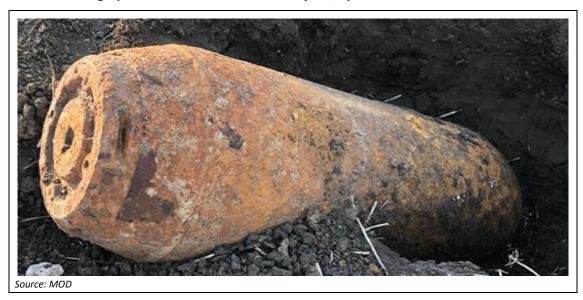
## Plate 22 Photograph of UXB discovered near Drayton, April 2020

Plate 22 is a photograph of the UXB.

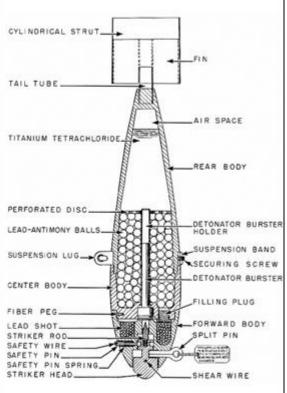
Specifi	cations	
Description	Pear shaped with single suspension lug and ring-bound four-fin tail	Function	Training (Smoke or Flash)
Dimensions	Total 406mm x 76mm (16" x 3")  Body 305mm x 76mm (12" x 3")	Activation by	Impact fuze
Material	Bakelite body, sheet metal tail	Variations	3 <del>.</del>

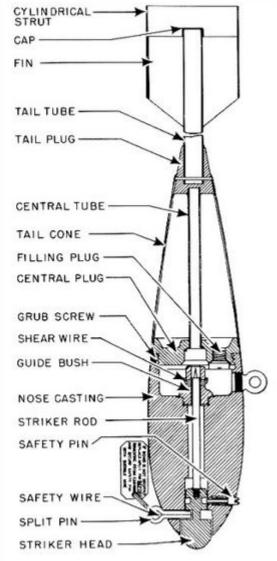
Specifi	cations	
Description	Pear shaped with single suspension lug and ring-bound four-fin tail	Function	Training (Smoke or Flash)
Dimensions	Total 457mm x 76mm (18" x 3")  Body 178mm x 76mm (7" x 3")	Activation by	Impact fuze
Material	Iron body, sheet metal tail	Variations	Variants with Bakelite tail

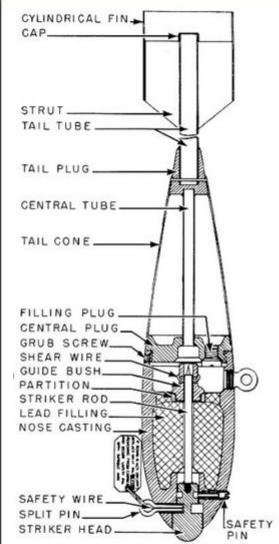
Specifi	cations	
Description	Pear shaped with single suspension lug and ring-bound four-fin tail	Function	Training (Smoke or Flash)
Dimensions	Total 457mm x 76mm (18" x 3")  Body 178mm x 76mm (7" x 3")	Activation by	Impact fuze
Material	Steel body, sheet metal tail	Variations	Variants with thicker tails or Bakelite construction

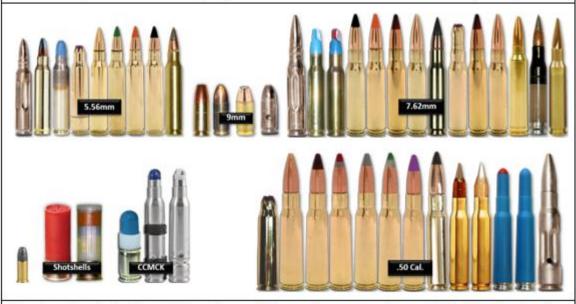
The above is an indicative selection of some of the most common calibres of SAA. It is not exhaustive. The appearance of SAA can vary considerably depending on their origin and intended purpose.

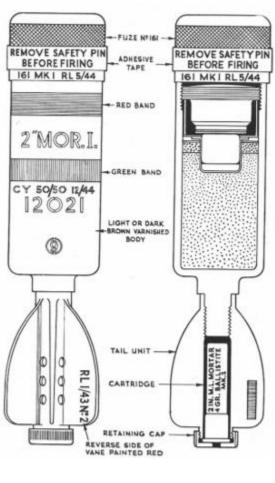
Specifi	cations		
Description	Cylindrical body with six- or eight-vane perforated tail	Function	Anti-Personnel (Fragmentation), Incendiary, Smoke, or Illumination	
Dimensions	Total 290mm x 50mm (11.4" x 2") Body 145mm x 50mm (5.7" x 2")	Activation by	Impact or Time fuze	
Material	Steel	Variations	Minor variations in length and shape dependent on function

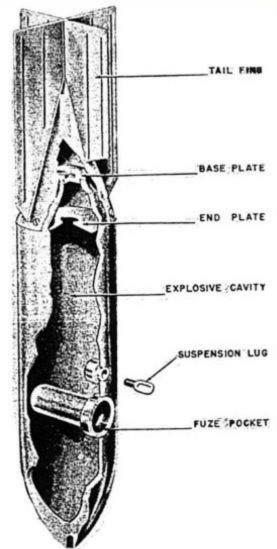
Specific	cations		
Description	Cylindrical with pointed nose and four-fin tail	Function	General Purpose (Blast and Fragmentation)	
Dimensions	Total 1090mm x 280mm (42.9" x 11")  Body 766mm x 200mm (30.2" x 7.9")	Activation by	Impact, Time, or Tamper fuze	
Material Steel		Variations	Minor variations in length

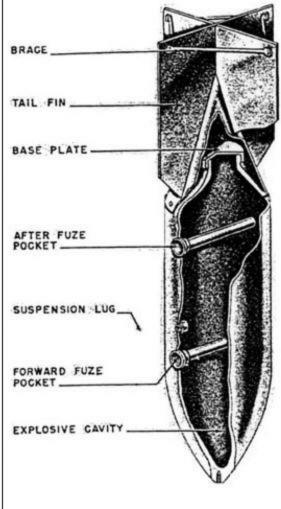
Specific	cations		
Description	Cylindrical with pointed nose and braced four-fin tail	Function	General Purpose (Blast and Fragmentation) Impact, Time, or Tamper fuze	
Dimensions	Total 1640mm×512mm (64.6" × 20.2")  Body 1172mm × 368mm (46" × 14.5")	Activation by		
Material	Steel	Variations	Minor variations in length

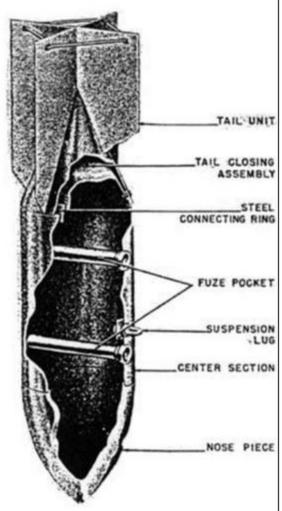
эреспи	cations	
Description	Cylindrical with pointed nose and braced or ring-bound four-fin tail	Function	General Purpose (Blast and Fragmentation)
Dimensions	Total 1957mm x 640mm (77" x 25.2") Body 1423mm x 470mm (56" x 18.5")	Activation by	Impact, Time, or Tamper fuze
Material Steel body, Steel or Magnesium Alloy tail		Variations	Minor variations in length

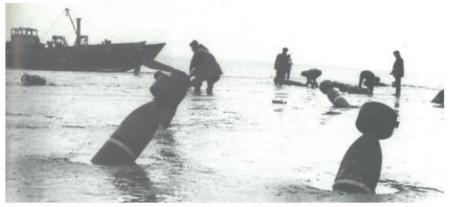
Retrieving practice bombs from a range in an estuary during WWII

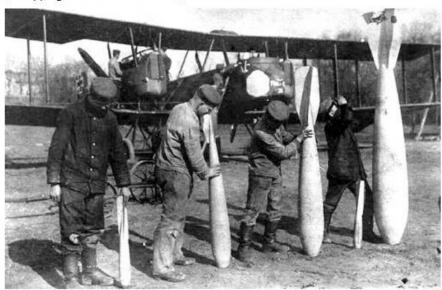
A variety of WWI German bombs

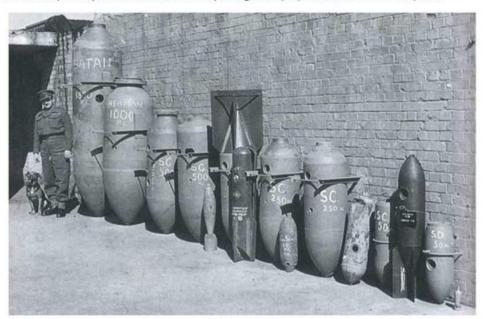
The German bombing campaign saw the extensive use of both High Explosive (HE) bombs and Incendiary Bombs (IBs). 50kg and 250kg HE bombs were most commonly used, although 500kg were also used to a lesser extent. More rarely 1,000kg, 1,400kg and 1,800kg bombs were dropped. HE bombs tended to contain about half of their weight in explosives and were fitted with one or two fuzes. Not all HE bombs were intended to explode on impact and some contained timing mechanisms where detonation could occur more than 70 hours after impact.

Variety of WWII bombs

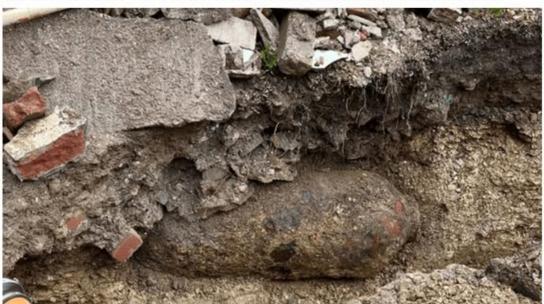
On the 20<sup>th</sup> February 2024, 1No. 500kg UXB was discovered in a garden in Plymouth (see below). An exclusion zone was put in place, evacuating approximately 3,250No. people over a course of 4No. days. On the 24<sup>th</sup> February the UXB was moved and detonated at sea by EOD teams.

500kg German UXB discovered in Plymouth, 2024

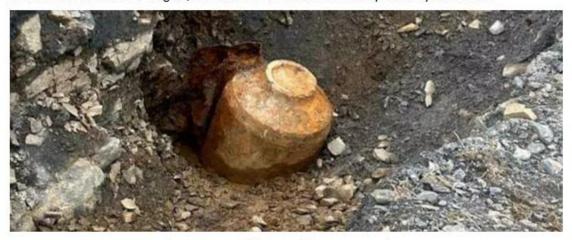
On the 15<sup>th</sup> August 2024, 1No. 500kg UXB was discovered at the building site in Newtownards, County Down (see below). A 400m exclusion zone was put in place, ahead of the planned detonation. On the 20<sup>th</sup> August, the UXB was detonated in situ by an Army EOD team.

500kg German UXB discovered in Newtownards, 2024

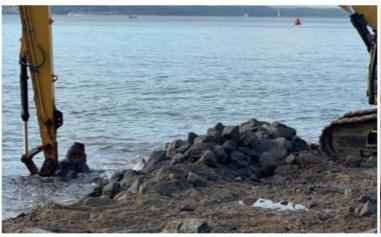
On the 3<sup>rd</sup> December 2024, 1No. 1,000kg UXB was discovered during coastal defence works near the Clarence Esplanade in Southsea, Portsmouth. The UXB was removed and detonated at sea.

1,000kg German UXB discovered in Southsea, 2024
